MERRIMACK RIVER BASIN
CLINTON, MASSACHUSETTS

LANCASTER MILLPOND DAM MA 00887

PHASE I INSPECTION REPORT NATIONAL DAM INSPECTION PROGRAM

JUNE, 1981

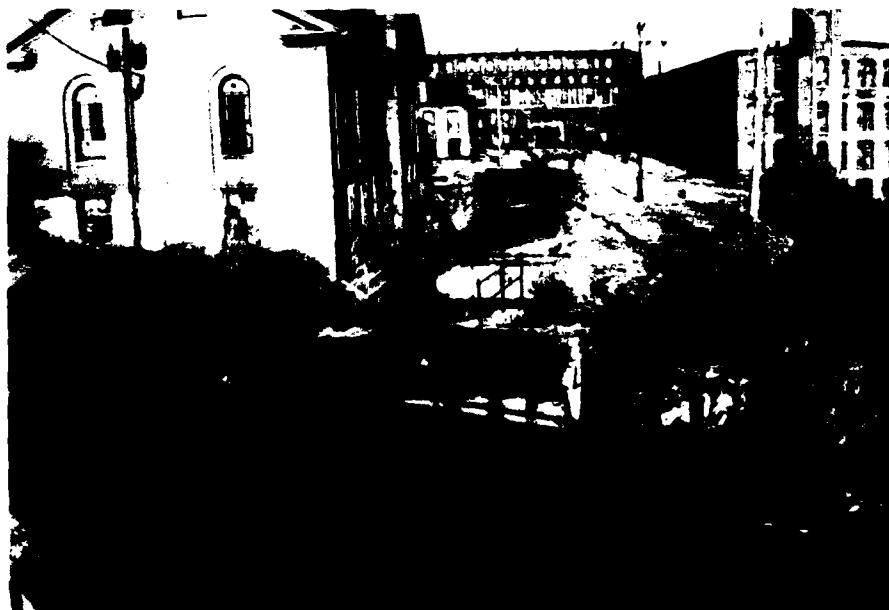
Photo No. 7 - Entrance to mill channel on left side of dam.
